**National Highway
Traffic Safety
Administration**

Case Vehicle (A): 1999 Volvo
 Type: S-80, 4-door sedan
 Driver: 34-year-old male
 CDC: 12-FDEW-2

Veh. (B): 1997 Dodge
 Type: Neon, 4-door sedan
 Driver: 25-year-old female
 CDC: 99-00000-0

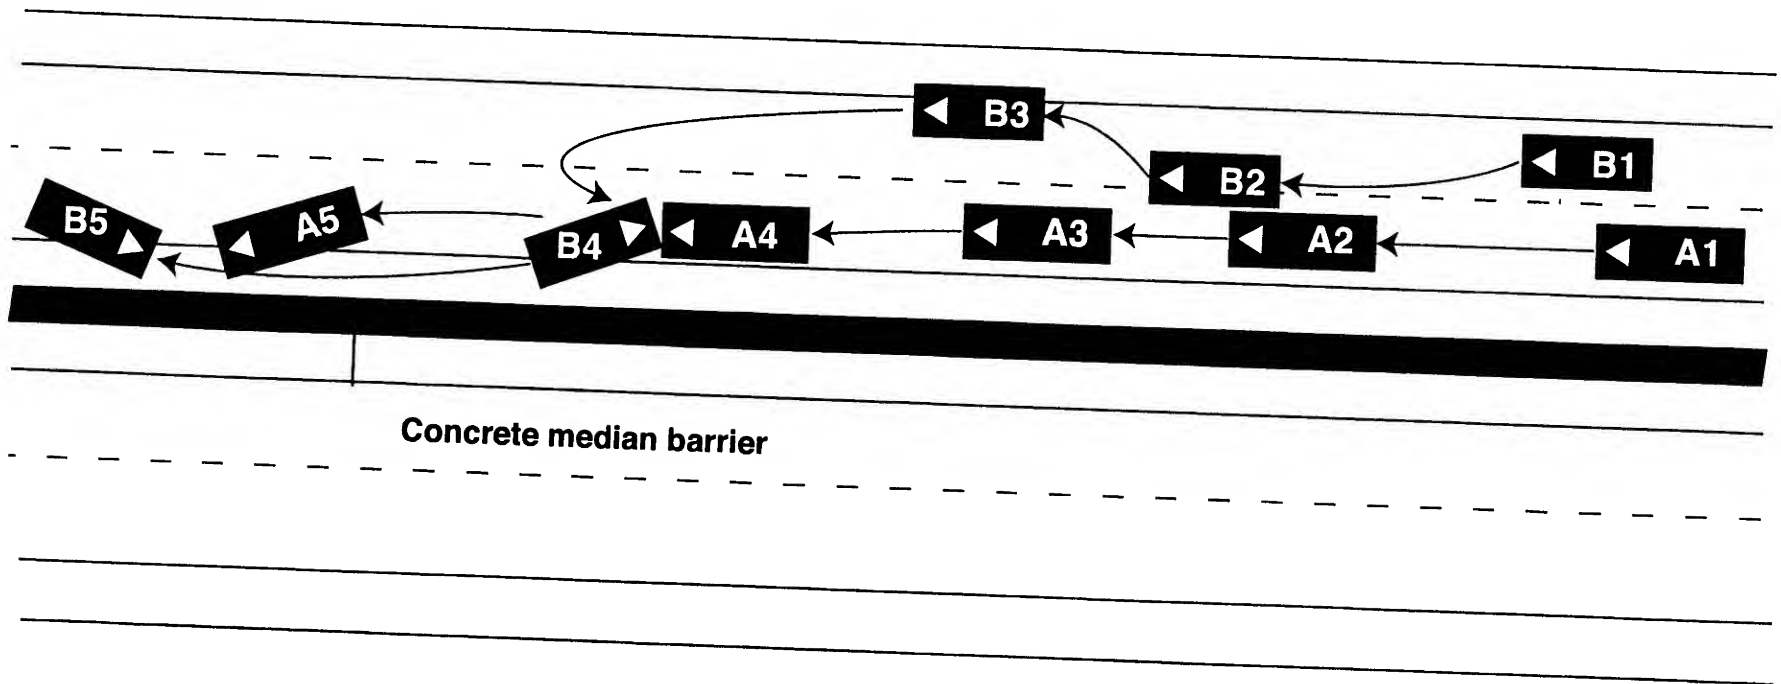
ACCIDENT SCHEMATIC

ACCIDENT DESCRIPTION: Case vehicle (A) and vehicle (B) were
traveling west, with vehicle (B) in the right lane and case
vehicle (A) in the left lane. Vehicle (B) attempted to
change lanes but the driver saw case vehicle (A) and steered to the right. Vehicle
(B) rotated 180 degrees, went into the path of case vehicle (A). The front of case
vehicle (A) struck the front of vehicle (B) in a offset mode.

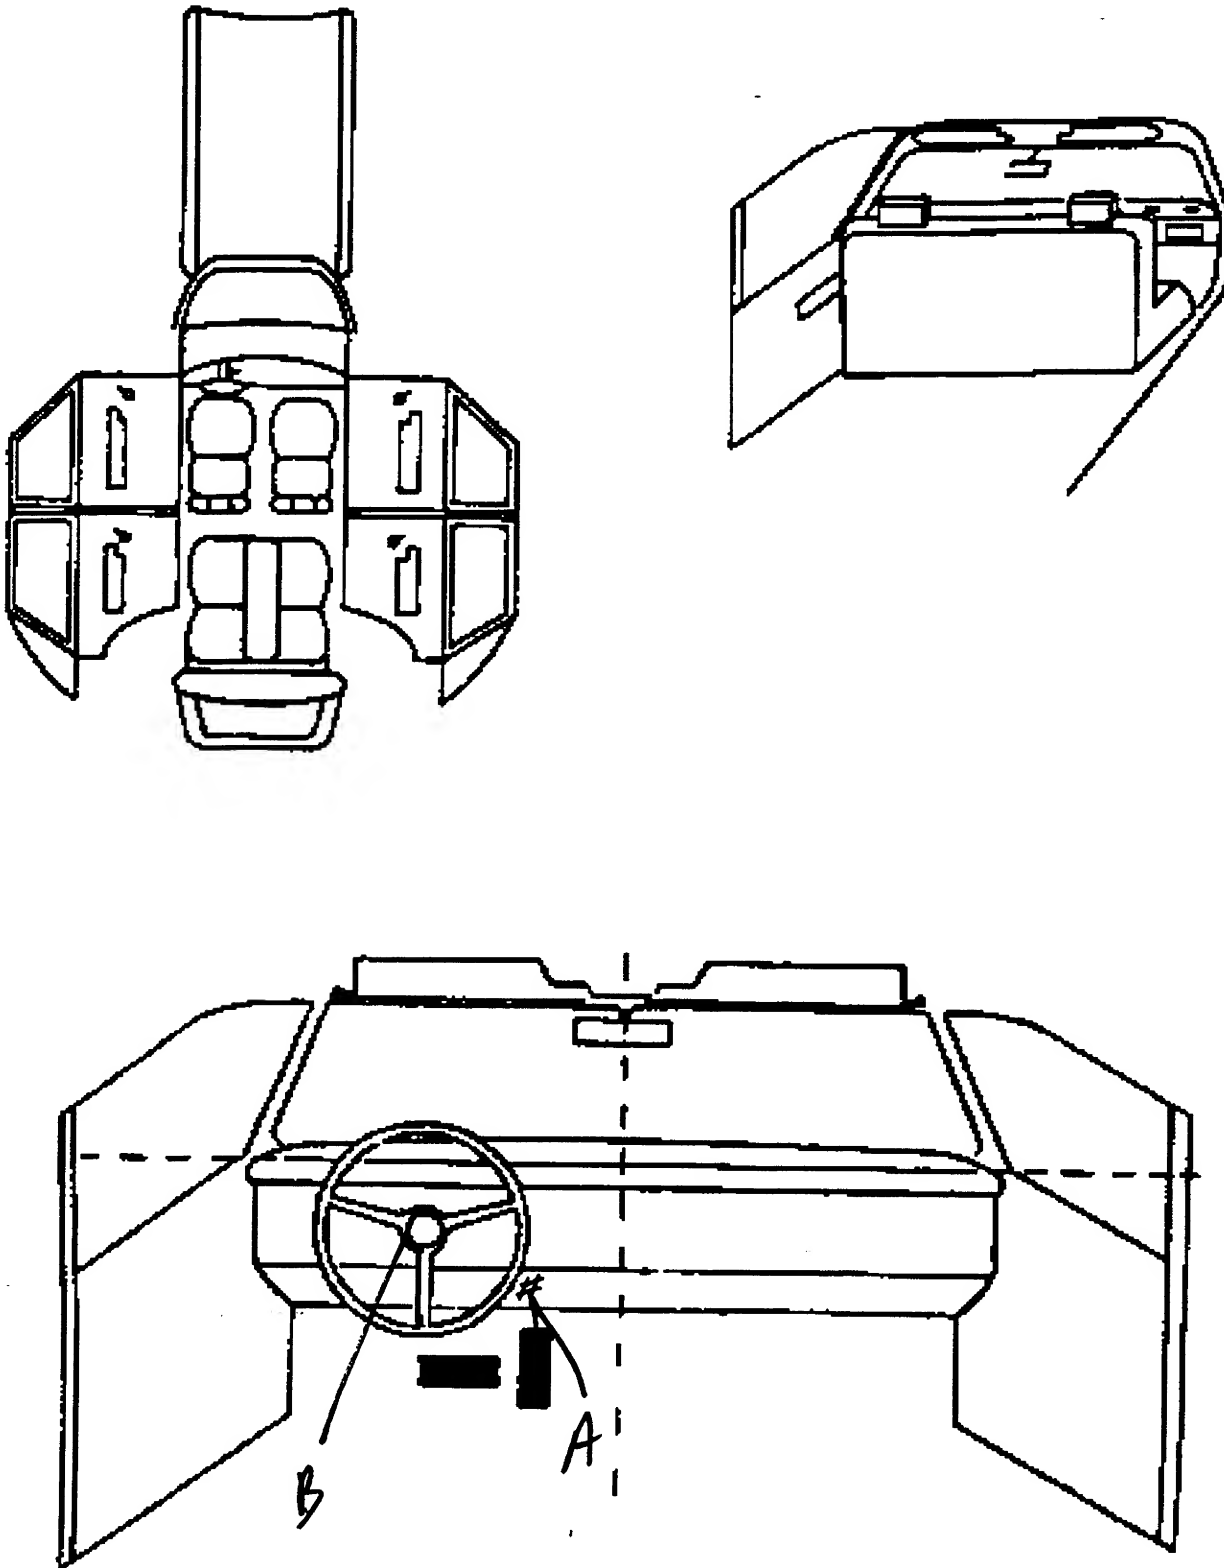
VEHICLE OCCUPANT CONTACT DIAGRAM

Contact	Interior Component Contacted	Occupant No. if Known	Body Region if Known	Supporting Physical Evidence	Confidence Level of Contact Point
A	Knee BOLSTER	DR	Rt Leg	Scuff marks	1
B	SW HVb	DR	Hand/Arm	MARK - NO damage possible burn	3
C					
D					
E					
F					
G					
H					
I					
J

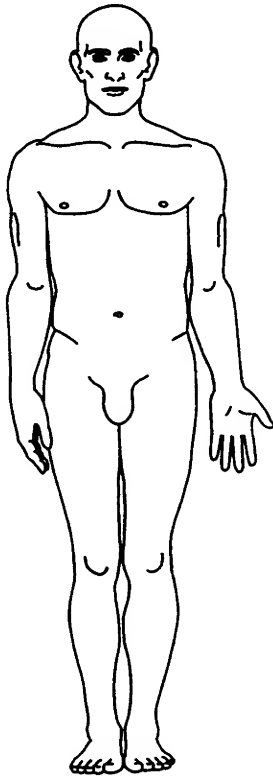
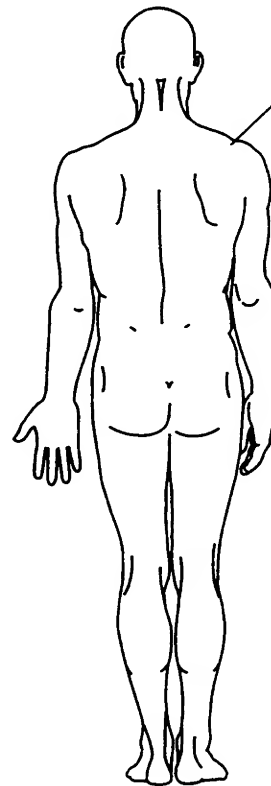
**Strain,
right
shoulder
(1)**
